Structure Monitoring Technology

From Deck to Cloud: Leak Detection Scanning for Inverted Roofs

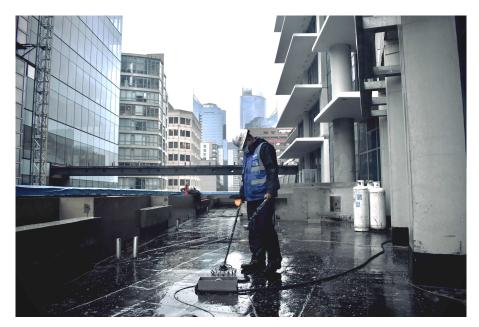
Above: An SMT Technician performs a DigiScan service on an inverted roof membrane

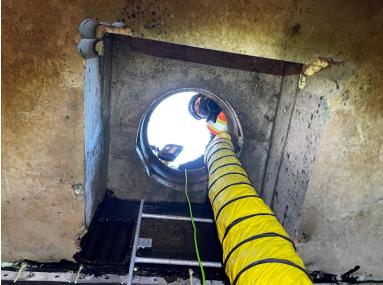
Above Left: SMT Technician uses a harness to scan a high-up ledge. Above Right: DigiScan Services can be used to check the waterproofing inside tanks and cisterns.

The flexible design of the DigiScan 360 tool allows scanning of areas that other leak detection tools cannot reach. SMT's operations manager will coordinate with the General Contractor to ensure any lifts/harnesses/other safety equipment are available and that our technicians are fully trained to operate in the area.

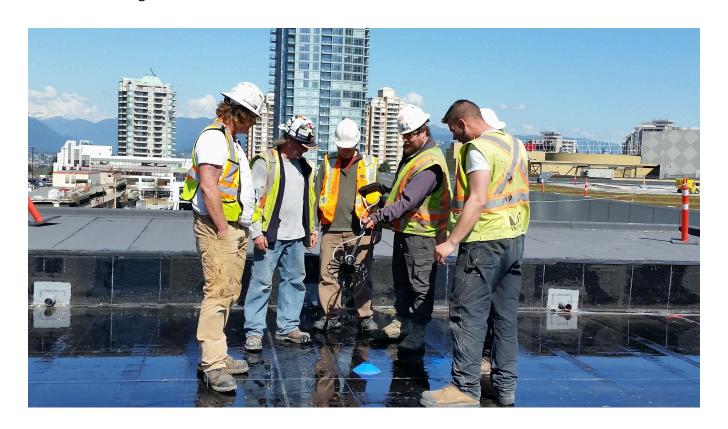
Above: An SMT Technician provides training with a DigiScan 360.

The current iteration of our electronic leak detection scanner - the DigiScan 360 - is available for purchase on the products page of our website. SMT offers a host of training and related services so you can start performing your own membrane integrity assessments.
